Due to the increase in demand for iron ore, particularly from China, a car dumper at the BHP Billiton Port Hedland Iron Ore loading wharf had to be upgraded.

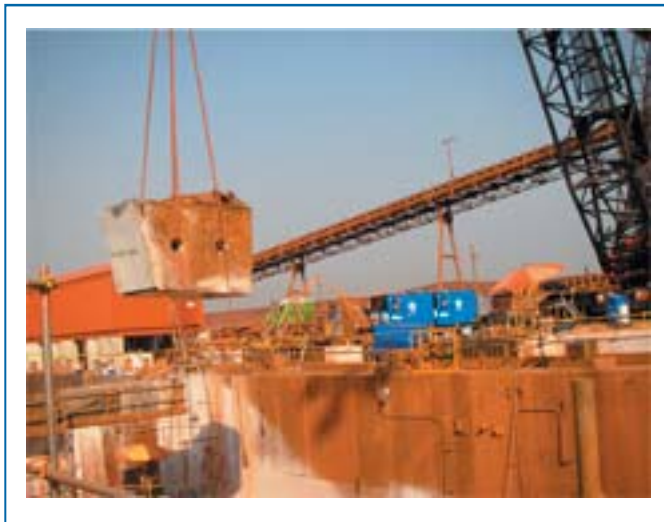
As part of the upgrade 700 tonne of concrete had to be cut and removed from the dumper. As the removed concrete had to be transported by road, most of the concrete was cut into 20 tonne pieces.

Some of the cutting involved forming openings in floors for ventilation and was relatively straight forward, even though the concrete was up to 3m thick. Other parts of the project were more complex.

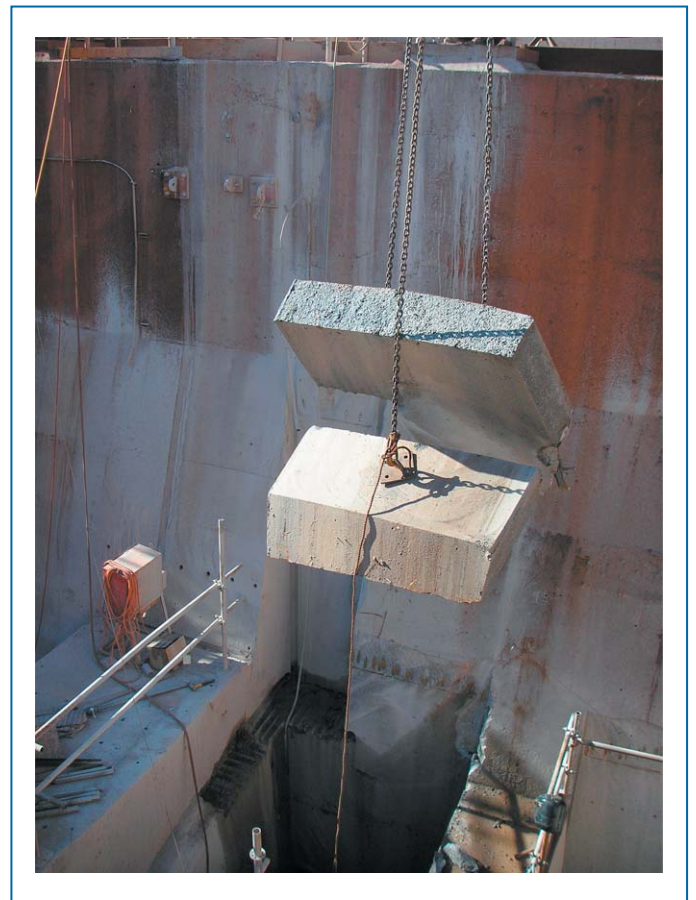
Recesses had to be formed in sloping walls to accommodate the stabilizers for the new dumper. These were “blind” so the bottom had to be formed first to allow the back and sides to be cut.

In total about 500 square metres of wire sawing was completed along with about 700m of drilling for wire and lifting holes.
